**Title:****Service Campaign SC 03/01
Exhaust Gas Temperature Sensors (EGTS)****Applicability:**

Bentley Arnage T

Bentley Arnage R

Bentley Arnage RL

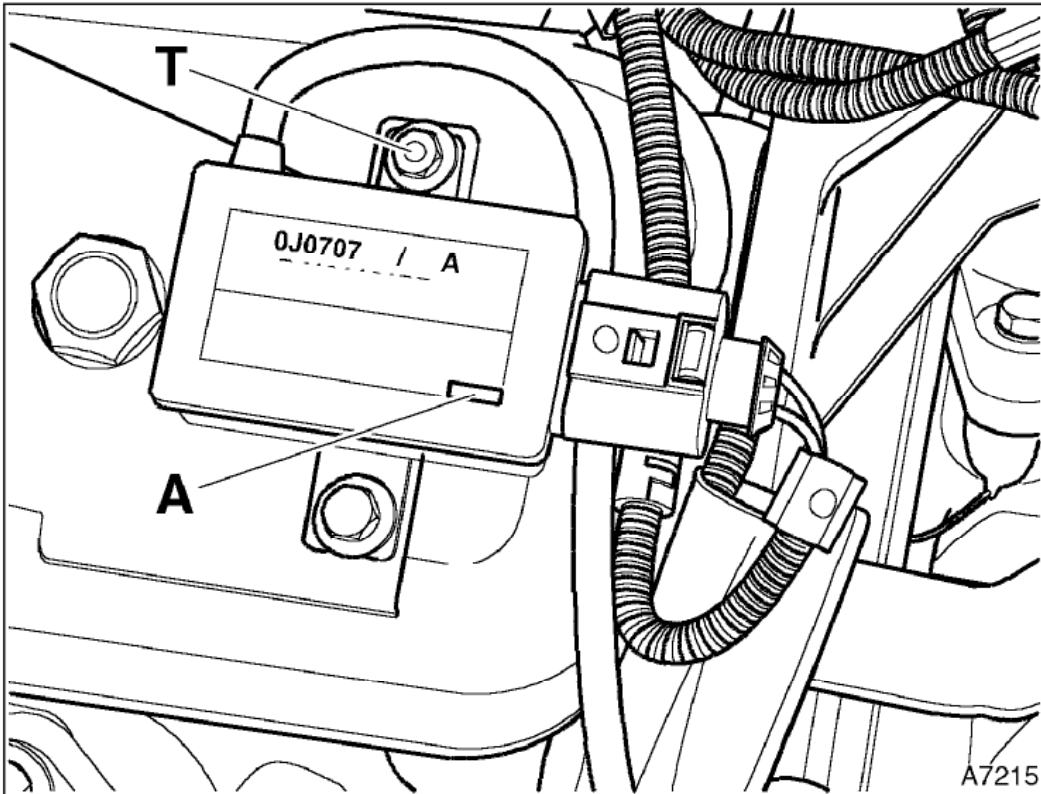
Figure. 1

The sensor date code A, is visible on the outside of the control box. See figure 1. If the date code is not 2102 or 2502 no further action is required and a white spot of paint should be applied to the upper fixing bolt head of the Control Box. See figure 1 item T. Should the date code be one of those affected carry out the replacement procedure.

Apply a small amount of anti-seize grease onto the threads of the probe retaining nut. Take care not to bend the probe when fitting into the turbocharger flange and set the probe tube to the vertical position. Make sure that the sensor cable is not twisted and is free from kinks then **torque tighten** the retaining nut. The remainder of the refit process is the reversal of the removal. On completion of the work a white spot of paint should be applied to the upper fixing bolt head of the Control Box. See Figure 1 item T.

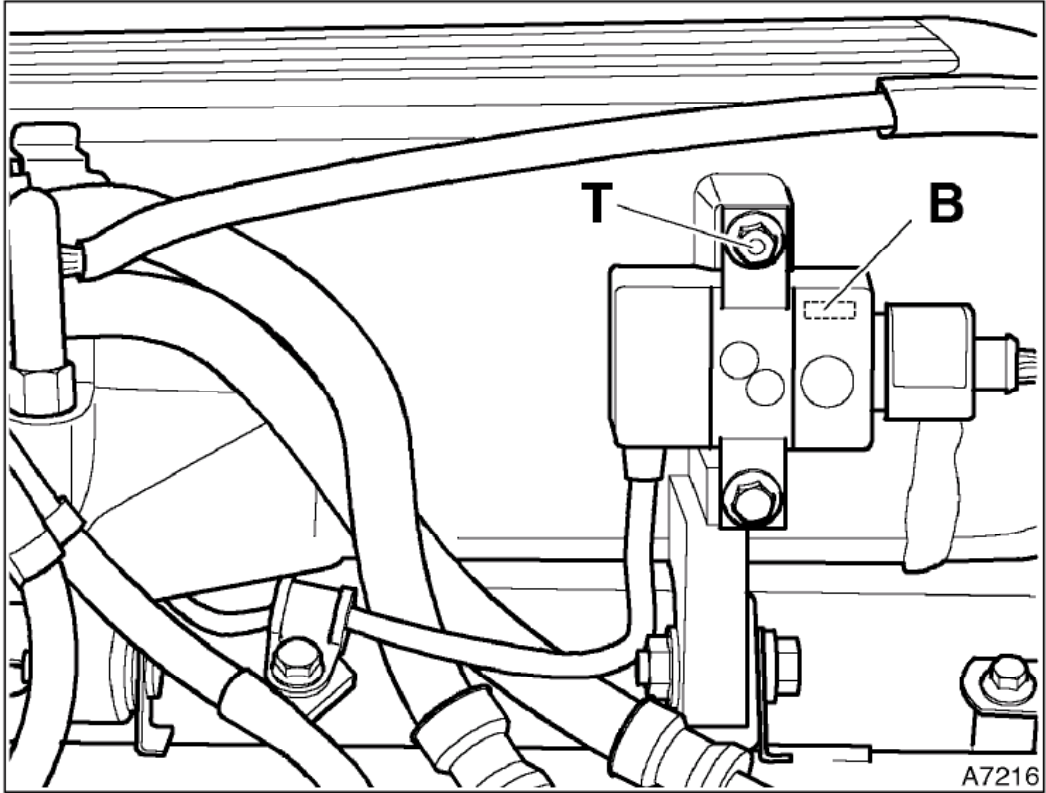
Figure. 2

To gain access to the date code B, you will need to remove the 2 bolts, which retain the control box and then carefully rotate the unit. See figure 2. If the date code is not 2102 or 2502 no further action is required and a white spot of paint should be applied to the upper fixing bolt head of the Control Box. See figure 2 item T. Should the date code be one of those affected carry out the replacement procedure.

The remainder of the refit process is the reversal of the removal. On completion of the work a white spot of paint should be applied to the upper fixing bolt head of the Control Box. See Figure 2 item T.
