# Technical Information

911 (996)

## Noises at the Windshield and Rear Window

Vehicle Type: **911 Carrera (996)**

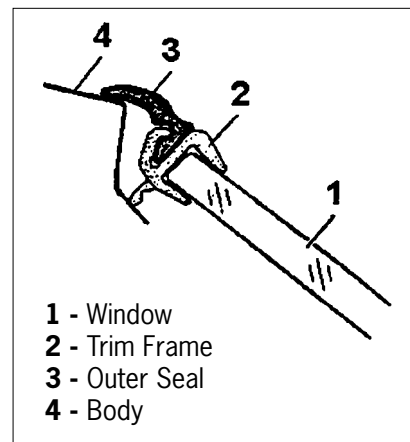
**Figure 1**

Information: Rattling noises can occur if the trim frame around the windshield and/or rear window becomes loose. The bonding of the trim frame around the windshield (and the rear window on the Coupe) was improved in production, as of November 19, 1998, and from Vehicle Identification Numbers: (VINs)
