## SERVICE BULLETIN

<b>To:</b>	All Dealers	<b>Reference</b> SB0286V2
<b>For the attention of:</b>	Service Manager/After Sales Manager	
<b>Please copy to:</b>	The Dealer Principal Aston Martin Technician(s) The Parts Manager	
<b>Model:</b>	All Models	<b>Issued:</b> 25 December 2009
<b>VIN Range:</b>	All	
<b>Subject:</b>	Rear Lamp Assembly Condensation Removal and Repair Procedure	
		Page 1 of 5

### Reason for this Service Bulletin

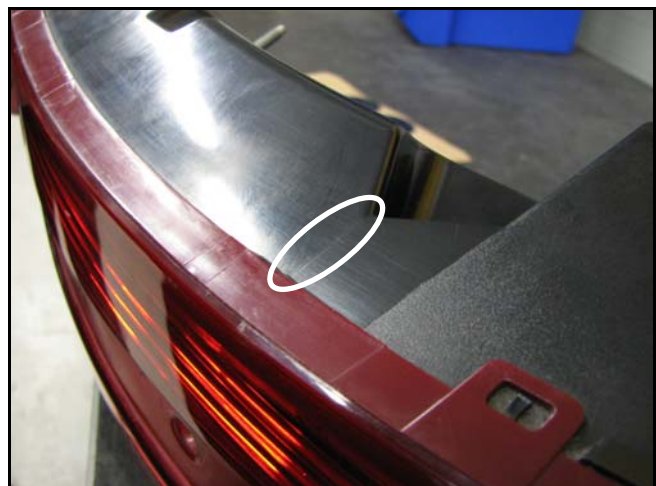
Figure 3

8. Turn the lamp unit to let the water drain out of the hole.
8. Find the location of the water leak (see the example in Figure 3). Refer to 'Water Leak Locations' after this Workshop Procedure for the usual crack or split locations.

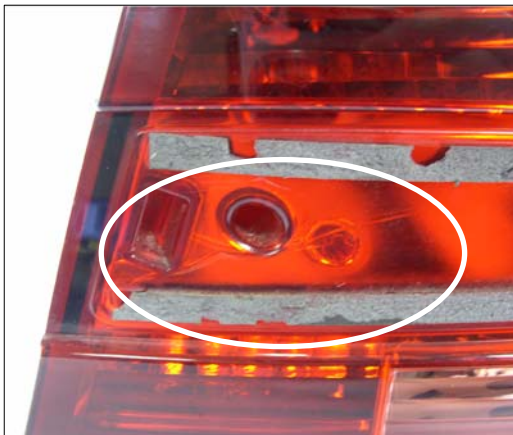
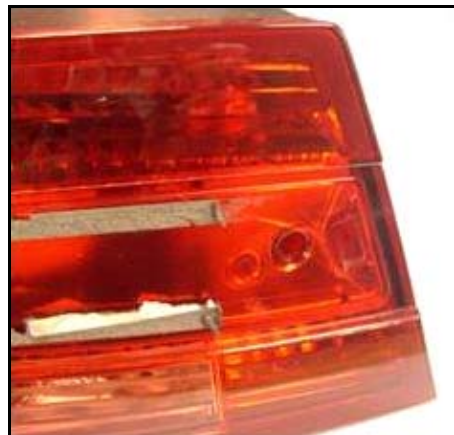
- A crack in the lens under the infill panel (Figure 7 and Figure 8).
- Cracks in the housing around the mounting points (Item A, Figure 9), rub-through on the edge of the lens (Item B, Figure 9) and lens/housing separation because of load between the lens and the panel (Figure 10).

13. Dry the damaged area with an airline.
14. Degrease the damaged area.
15. Use cyanoacrylate adhesive to seal all small cracks found and make sure that you fully seal the crack. For larger holes use an applicable 2-part epoxy adhesive.
16. Clean the area around the drilled hole with applicable alcohol cleaner and cloth.
