Questions & Answers

Get familiar with it:
The water-cooled 996
flat six, disassembled
for all to see...

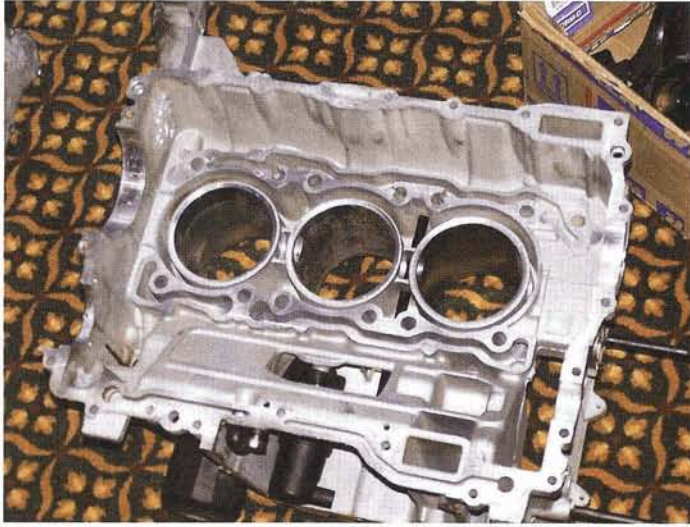
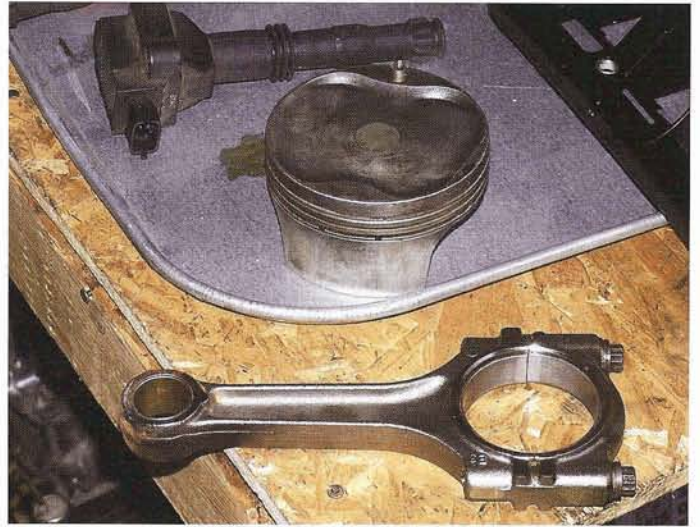
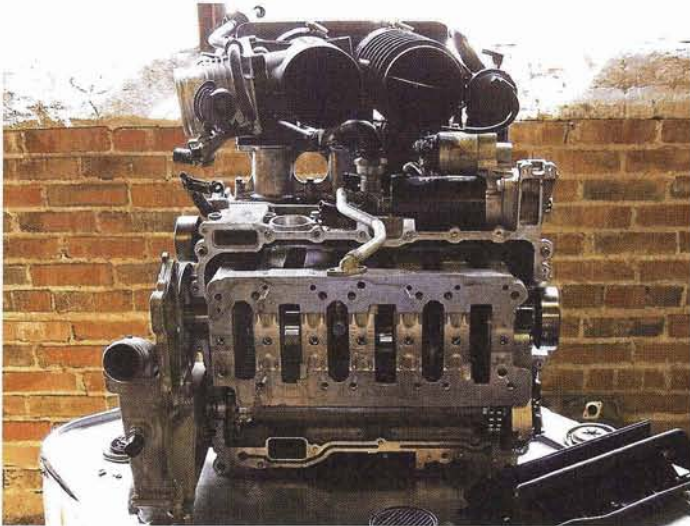
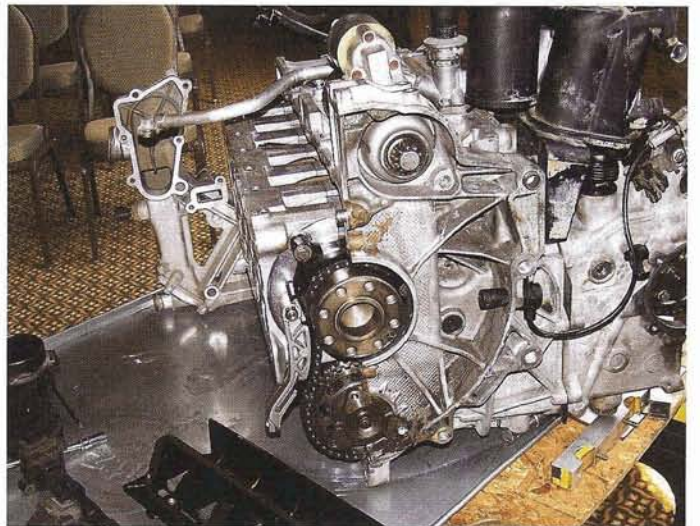
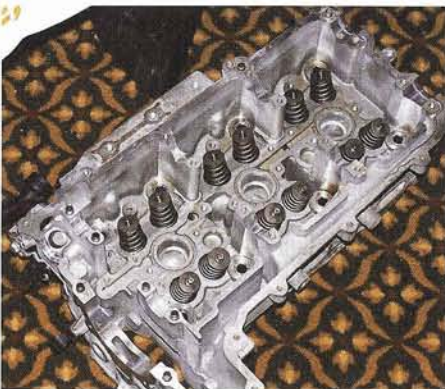
Combined cylinder bank/outer crankcase casting (top, left) was chosen to simplify the manufacturing process. Connecting rod (top, right) for a 3.4-liter 996 engine; piston is dished for the four-valve heads. Partially disassembled 996 engine seen in profile, with the iron main-bearing saddle clearly evident (above, left). Another view of the main-bearing saddle (above, right). Four-valve 996 cylinder head (left) showed little wear after 100,000+ miles, though the chain ramps for the 996's VarioCam timing system did show their age...

The 296-hp water-cooled, DOHC flat six had well over 100,000 miles when it began to exhibit a compression problem. It was removed from the car and disassembly revealed upper cylinder cracking due to the fuel contamination. Otherwise, the engine was in good condition when it was disassembled. The first thing we noticed was that cylinder wear was almost non-existent. The bear-

ings and rings also showed very little wear, even at 100,000 miles. The chain ramps for the VarioCam, however, seemed to have heavy grooving that's similar to what we've seen on 944S, 944 S2, 968, and 928 S4 engines that use similar tensioner arrangements. The 996 camshaft-drive chains did not appear to be stretched or damaged, though. At least these items can be replaced without totally disassembling the engine.
