Brake expectations

Porsche Ceramic Composite Brakes (PCCB) – what are they, and should they be seen as the Holy Grail of performance brakes? In the third part of our three-part feature, we examine further problems and determine their causes and incidence, plus how to avoid them

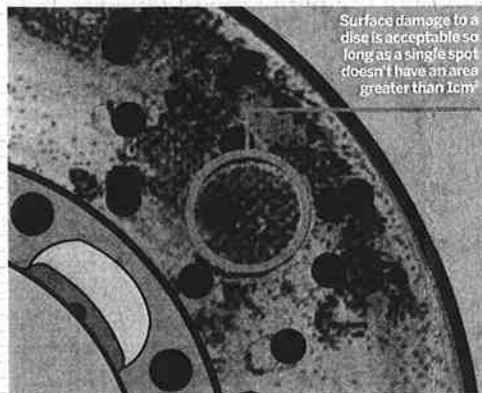
Surface damage to a disc is acceptable so long as a single spot doesn't have an area greater than 1cm²

- ⑤ Note that areas of roughness, if present, should not exceed 1cm² at any point. That is to say, any area of 1cm² must not consist entirely of worn, roughened surface. They are, however, a sign that wearing of the surface is taking place.

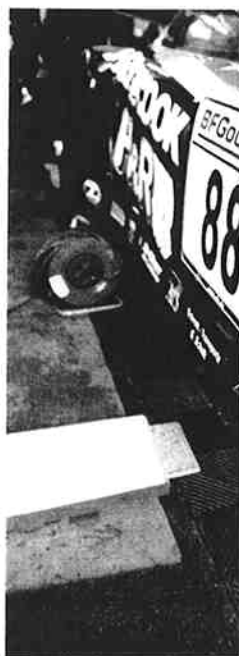
A 996 Turbo first-generation disc with damage and blocked cross-drillings. Note, too, that the caliper is discoloured due to overheating

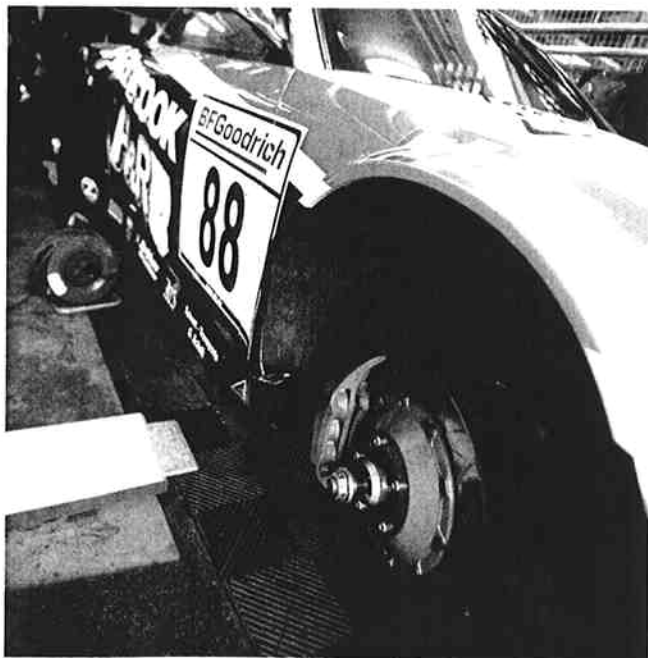
After trackday use a cooling-down lap is essential. PCCB will not cool adequately or evenly when the car is at rest back in the paddock (left), as they have been deprived of the vital flow of cooling air

For many trackday participants, it's a problem made worse by a failure to allow the brakes sufficient time to cool before the car becomes stationary at the end of the session – a cooling-down lap, with minimal use of the brake pedal is an essential part of the process of caring for PCCB, especially with regard to the brake pads. They will not cool adequately or evenly when the car is at rest back in the paddock, as they have been deprived of the vital flow of air through the body of the discs.

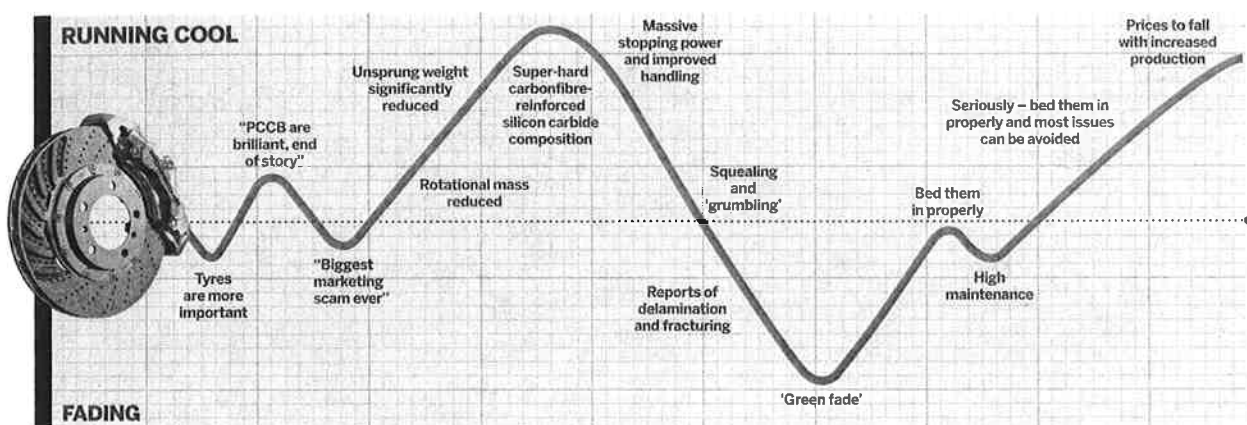
Follow the bedding-in procedure, take extra care to maintain (this disc is having its drilling cleaned out) and your PCCB will last a very long time
