Automobile Status Report

2006 Bentley CONTINENTAL GT

Multi-Point Inspection Form

Additional Service Recommendations

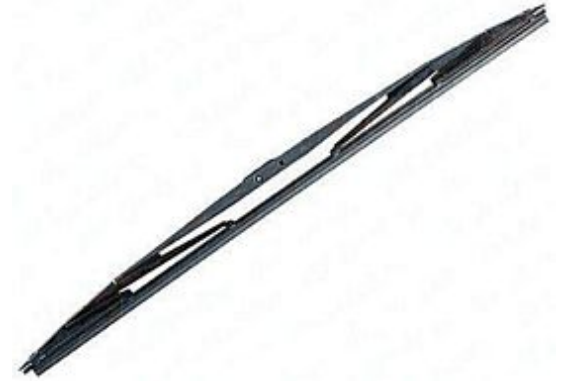
Windshield Wiper Blade

Wiper Blade Replacement - Front

If not replaced, worn out wiper blades can cause restricted visibility and permanent damage to the windshield.

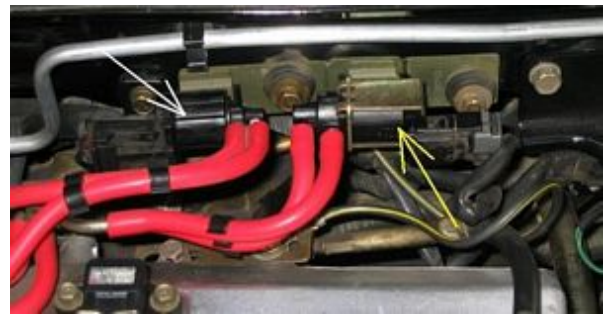
Purge Valve: Evap small leak. Recommend a new purge valve

The canister purge valve is controlled by the vehicle's computer, which allows it to monitor its performance.

If your car's computer detects higher or lower than expected purging from the valve, it will illuminate the check engine light. Common error codes include P0441 and P0446, as well as other EVAP codes.

If your canister purge valve is not opening properly, it may adversely impact your gas mileage. The reason for this is that the vapors that your car regularly uses in combustion will find the EVAP canister and eventually be vented to the environment, meaning that you will lose a portion of the fuel regularly used in burning. If your canister purge valve is stuck open, however, it creates a vacuum leak that can affect your engine adversely. Simply put, air will be allowed to enter the engine in a quantity that is not predicted by your car's computer. This will change the car's air to fuel ratio, and can cause rough idling as well as difficulty starting.

If not repaired, a faulty purge control solenoid can keep the engine's purge valve from operating at optimal performance or operating at all. An inoperable purge valve disrupts proper air flow and air/fuel mixture of the engine which can prevent the engine from running altogether.

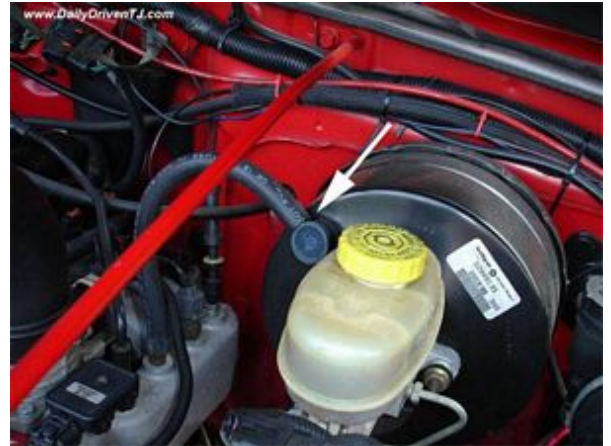
Vacuum Line Replacement: Found bank 2 plastic vacuum hose cracked. Recommend replacing both banks. This requires removing the engine.

The vehicle's vacuum system provides a lower atmospheric pressure that transforms a vehicle's engine into a large pump that sucks in air, mixes it with fuel and expels it along with combustion gases. Even light damage to one of the vacuum conduits can cause an array of performance problems.

Faulty vacuum lines will directly result in multiple problems for the vehicle including but not limited to: an increase in idle speed, a hesitation or misfiring during acceleration, and in some cases a non-working engine.

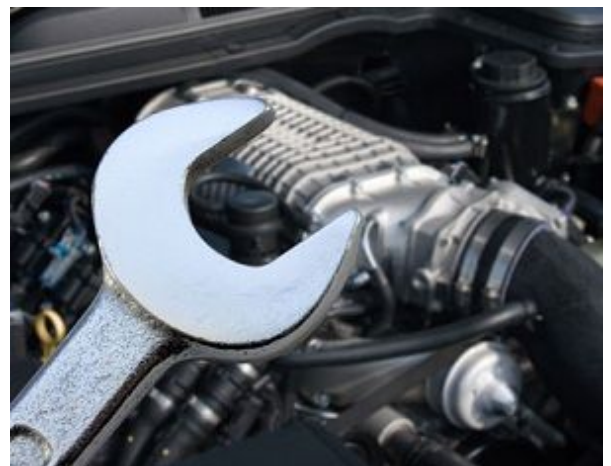
Tune Up 4 Cyl

The intent of a tune-up is to obtain the maximum performance and economy of an engine with the lowest possible exhaust emissions. This is so the vehicle engine meets the manufacturer's specifications. It involves checking the components of the ignition system and cleaning or replacing them; cleaning and adjusting the carburetion or fuel injection system; adjusting the points and timing cleaning and gapping the spark plugs. Tune-ups should be performed according to the recommendation of each manufacturer.

If not done, engine will lack best possible performance and good fuel economy.
