Fault codes 8, 9, 24, 25, 38

Passenger's belt tensioner

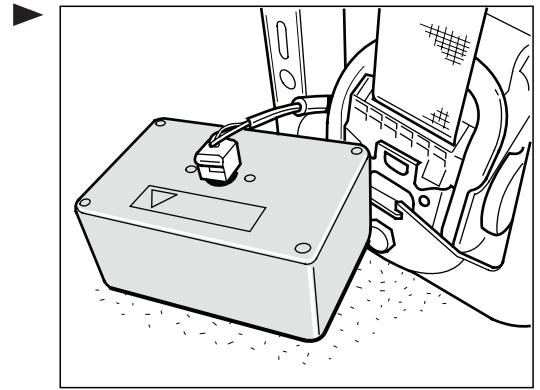
Work instruction			Display OK	If not OK
2	Visual inspection	Check whether the plug connection is correctly connected and locked	⇒ Step 3	Insert plug connection → End
3	Check belt tensioner	<ul style="list-style-type: none"> ◆ Switch off ignition ◆ Pull off plug on belt tensioner ◆ Connect test tool No. 9516/4 ◆ Switch on ignition ◆ Read out fault memory ◆ Erase fault memory ◆ Switch ignition off and remove ignition key ◆ Switch on ignition ◆ Read out fault memory 	Replace belt tensioner → End	⇒ Step 4

Test tool No. 9516/4 instead of belt tensioner

- ◆ *The contacts in the belt tensioner are very sensitive.*
- ◆ *When connecting test tool No. 9516/4, ensure that both special tool contacts are connected in parallel and simultaneously.*
- ◆ *Once connected, the plug must be locked; this allows the electrical connection to be made.*
