| SERVICE BULLETIN | | |
| <b>To:</b><br><b>For the attention of:</b><br><b>Please copy to:</b> | <b>All Dealers</b><br><b>Service Manager/After Sales Manager</b><br><b>The Dealer Principal</b><br><b>The Warranty Supervisor</b><br><b>Aston Martin Technician(s)</b><br><b>The Parts Manager</b> | <b>Reference</b><br><b>SB0283</b><br><br><b>Issued:</b><br><b>03<sup>rd</sup> February 2009</b><br><br><br><b>Page 1 of 10</b> |
| <b>Model:</b> | <b>V8 Vantage, Coupe and Roadster</b><br><b>DB9, Coupe and Volante</b><br><b>DBS</b> | |
| <b>Subject:</b> | <b>Satellite Navigation Display Screen, Repair to the Transport Mechanism</b> | |

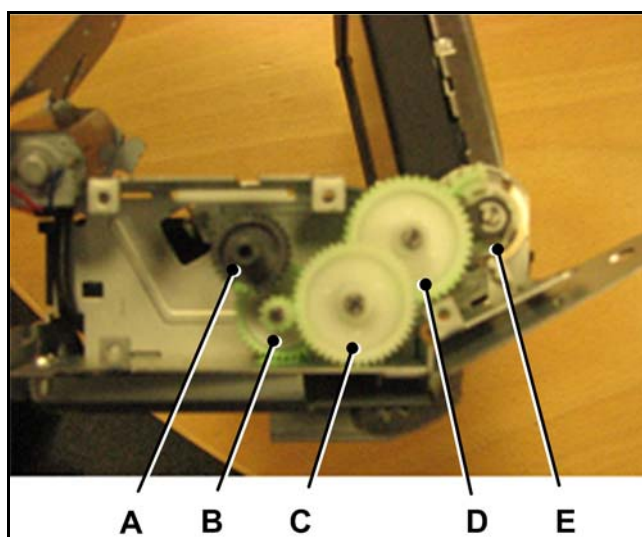
Figure 1

There have been some occurrences where the Satellite Navigation (Sat Nav) display screen will not move. The cause has been identified as Gear E in the transport mechanism (see Figure 1). The manufacturer of the system has released a repair kit to install a new Gear D and a new Gear E. Follow the Workshop Procedure to do the repair.
